NJUG CASE STUDY

CASE STUDY 44: Vertical Valve Injection Kit and Live Camera Inspection

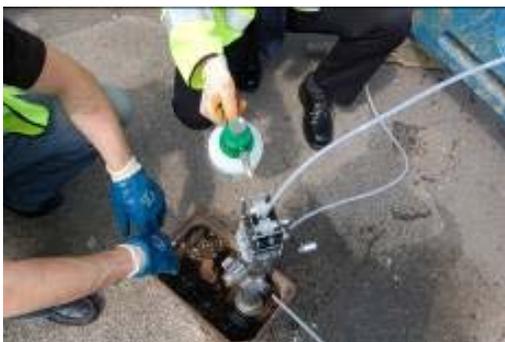
Live Camera Inspection

Following extensive research, BBUS worked with a partner to develop a camera system for one of its clients, Yorkshire Water, which provided a unique solution to internal pipe inspection, utilising advances in camera technology. The system can now carry out visual inspection of small-bore pipework in live water mains up to 150 metres from the access point, removing any risk of further damage to assets.

The camera inspection system is specifically designed to enable quick inspection of live water mains through entry of existing water network hydrants, which eliminates the need for excavation. The use of existing fire hydrants for which supply can be maintained also removes disruption to both traffic and customers.

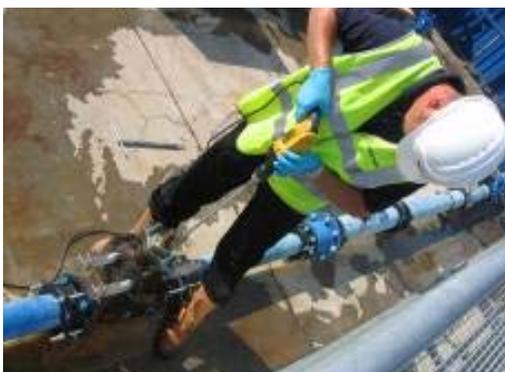
Vertical Valve Injection Kit

The BBUS VVI repair kit uses a combination of existing pressurised injection technology along with an innovative step change in application, by designing an extended drilling and jig system which allows trained operatives to drill vertically through the valve chamber and access the valve gland. Once the drilling and tapping is completed, a gland repair material is injected into the void to repair the valve.
